A Halloween horror story at Excelsior Motors

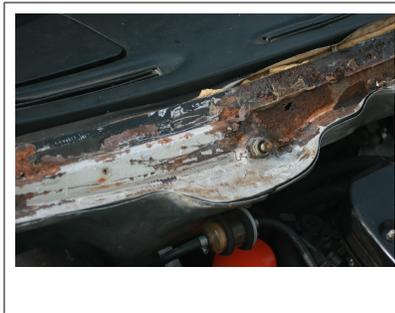
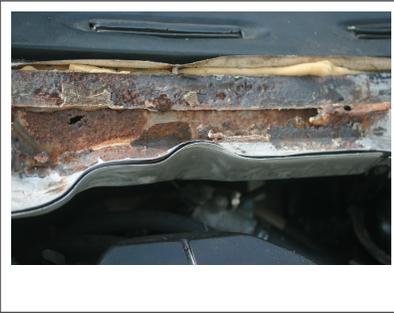
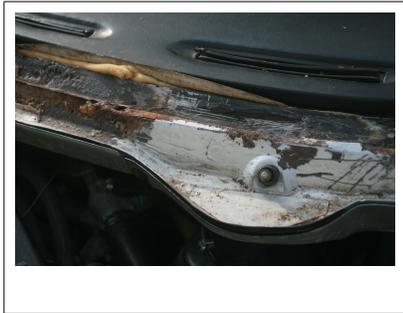
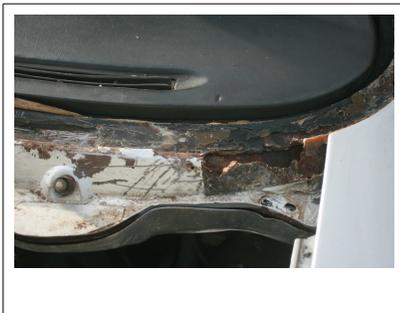
A customer brings in his 72 SM for a windshield after a minor mishap in the storage garage. The car is a California car with good paint showing little to no rust. The windshield comes off with little drama except that the wrong adhesive was used which made cleaning the channels take a bit more time. The A pillars channels look pretty good with a bit of surface rust. The roof channel looks pretty good. The horror comes along the bottom edge of the windshield. A previous fix was amateurish at best, a dishonest cover up at worst. Rust holes at the base of the windshield were filled with epoxy and strips of sheet metal glued over the larger holes. The result was bigger and deeper rust holes that grew with the cover-up job. See below if you dare.
